## Venture II refit

Venture II started off as a minesweeper in the 1940's She is 76 ft long, and weighs 58 Ton.

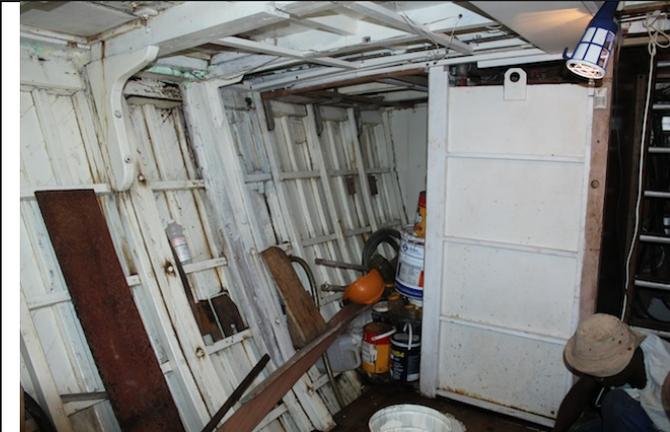
Mid cabin before. The dry rot was cut out of the bilges and supports rebuilt. The decks were leaking badly. The two diesel tanks next to stairwell were cleaned and fully serviced. Electrical wiring, switches, lights etc fitted.

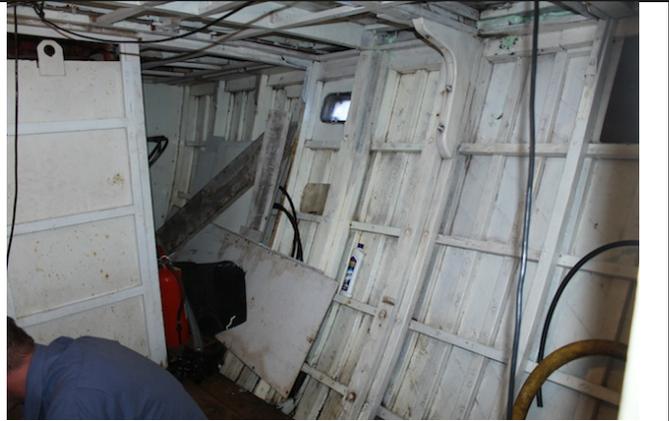
The mid cabin before. Two extra bilge pumps installed and years of sludge removed. New skin fittings were fitted for the heads and other replaced as well as an automatic electric shower well fitted for the shower.

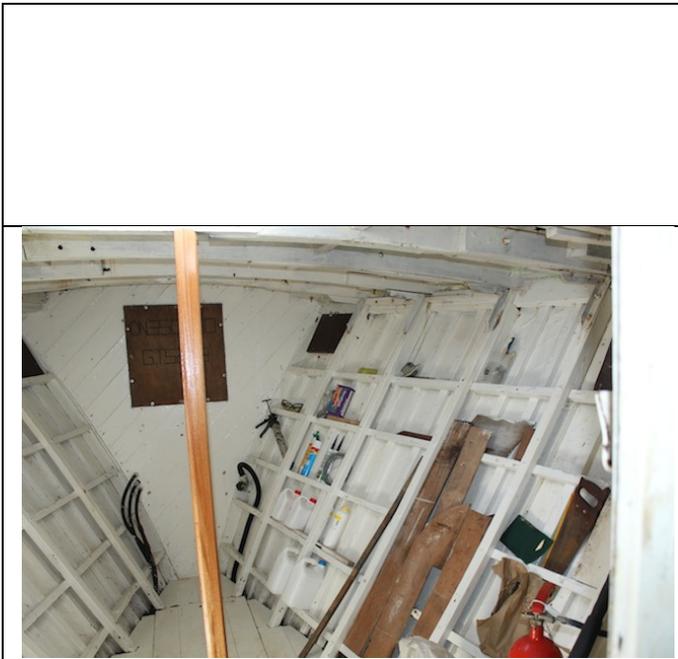
Forepeak after it was cleared out, propped up, reinforced and painted. It looked terrible and leaked like a sieve. Four removable water tanks were installed below floorboards with pump, gauge. Filler pipes and manifold

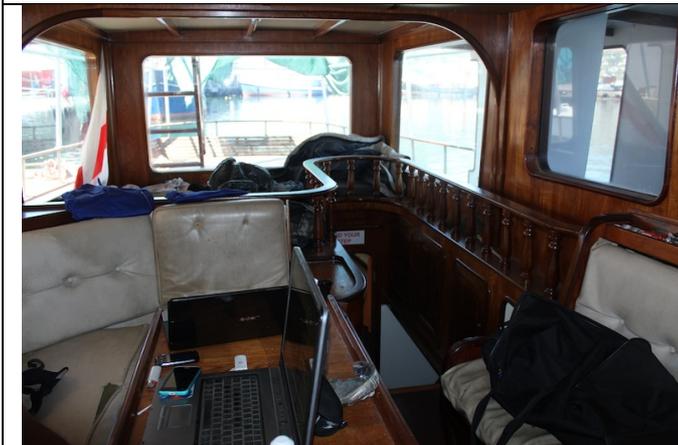
Old saloon.

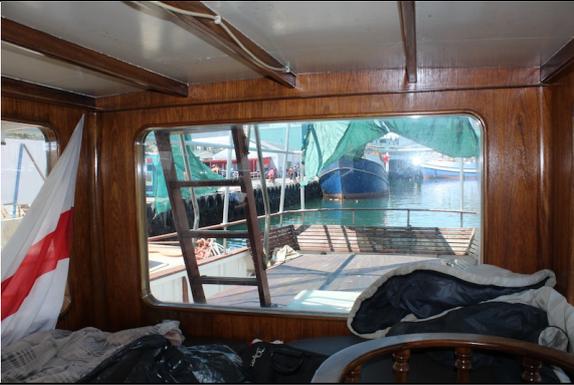
Day bed before

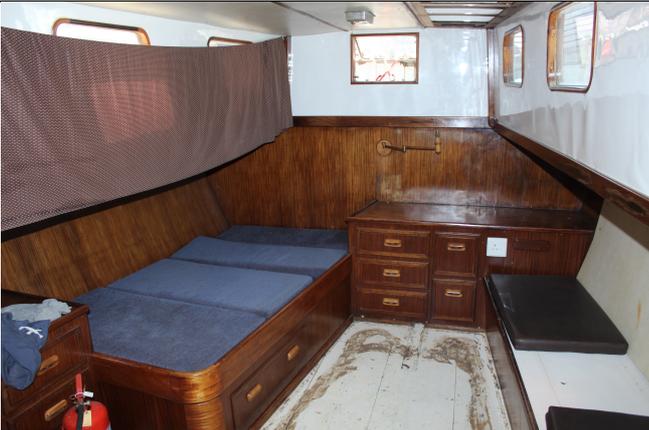
Aft Cabin before.

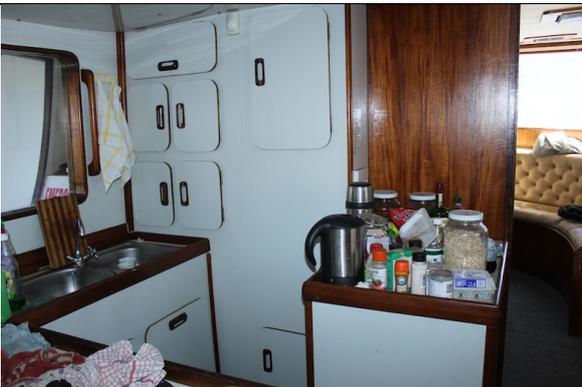
Galley before. There was no stove or hot water

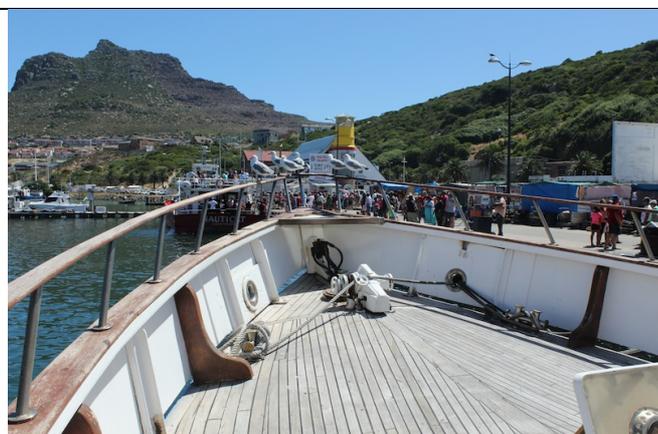
Decks were leaking all over especially the foredeck which once supported a 25 mm canon. Many deck supports were rotten and

needed replacing. Old repairs had to be removed and replaced as well.

Decks were sealed with Silkaflex, impregnated with penetrating epoxy, covered in 6 oz woven fiberglass matt impregnated with standard

epoxy. This leaves it ready for a thin layer of wood cladding of the owners choice.

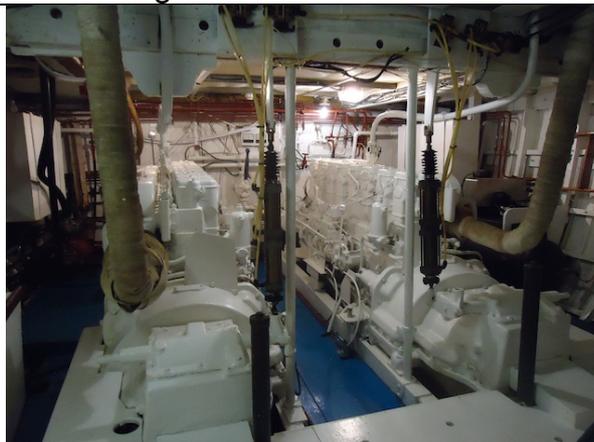
The engine room was a bit of a mess. Extra batteries and a charger had to be added and the day tanks fully refurbished.
