## Venture II refit

Venture II started off as a minesweeper in the 1940's She is 76 ft long, and weighs 58 Ton.

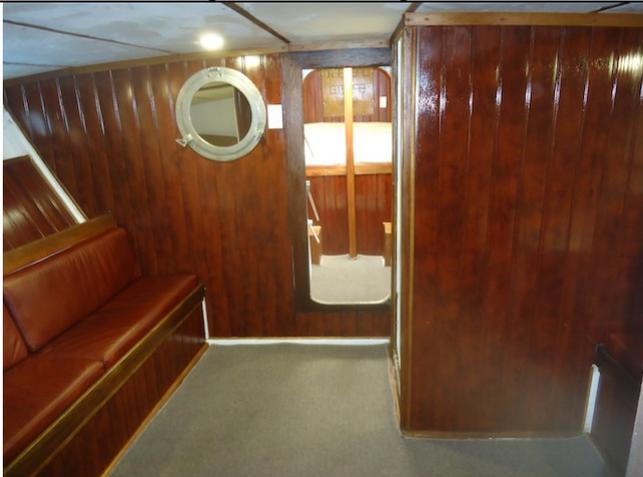
Mid cabin looking forward now. Heads and shower room to starboard of door.

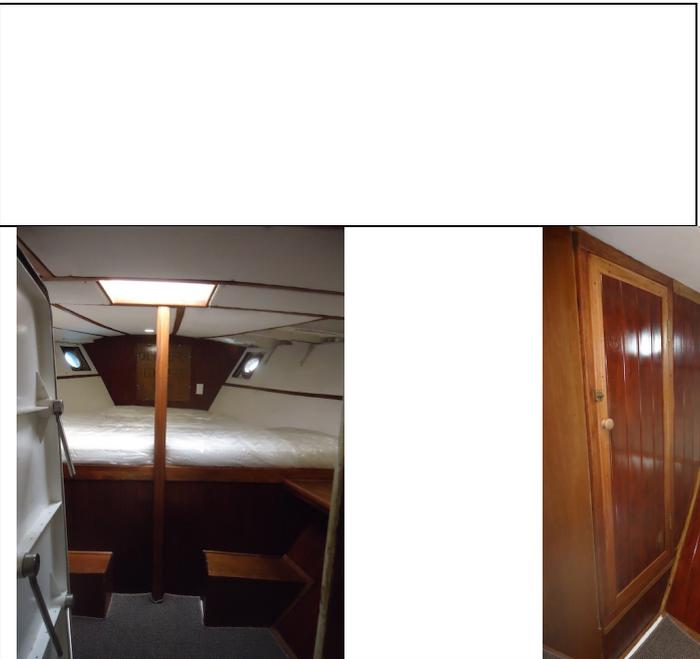
Forepeak with large double bed and wardrobe, behind the watproof steel door. A table and vanity cabinets on the starboard side. Easy access through ample storage bilges for insections by SAMSA

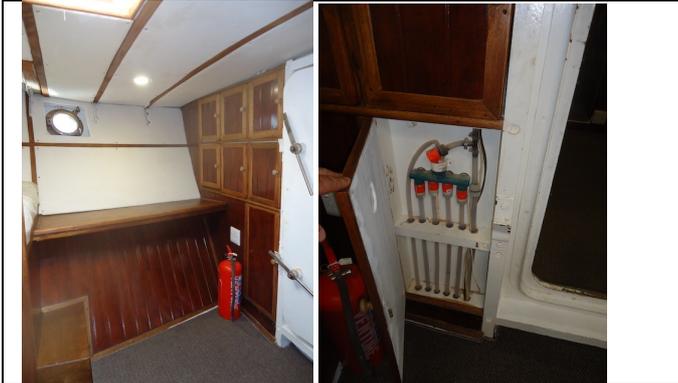
Table with cabinets and water tank management manifold. Gauge and switches hidden in cabinet above that.

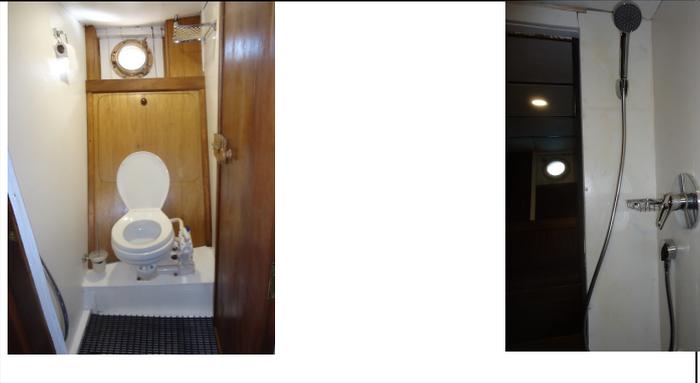
Heads and shower combination. Easy access to all skin fittings and piping. Four brass port lights installed across both cabins

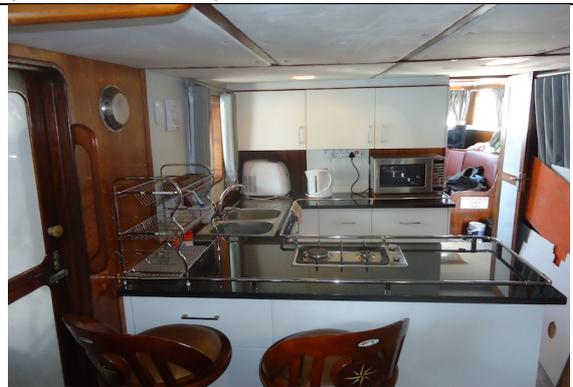
Galley with gas stove recessed in marble tops, double zink with hot water. All electrical wiring accessible behind cupboard spaces.

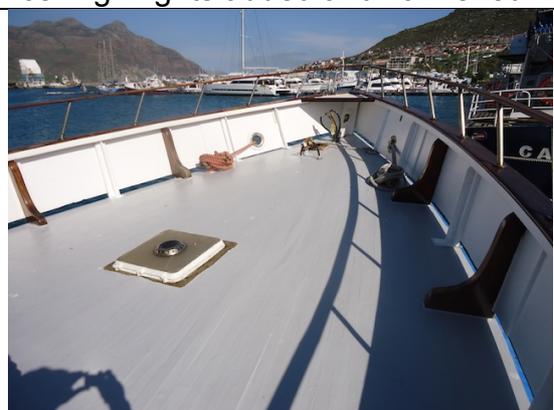
Decks were leaking all over especially the foredeck which once supported a 25 mm canon. Many deck supports were rotten and

needed replacing. Old repairs had to be removed and replaced as well.

Decks were sealed with Silkaflex, impregnated with penetrating epoxy, covered in 6 oz woven fiberglass matt impregnated with standard

epoxy. This leaves it ready for a thin layer of wood cladding of the owners choice.

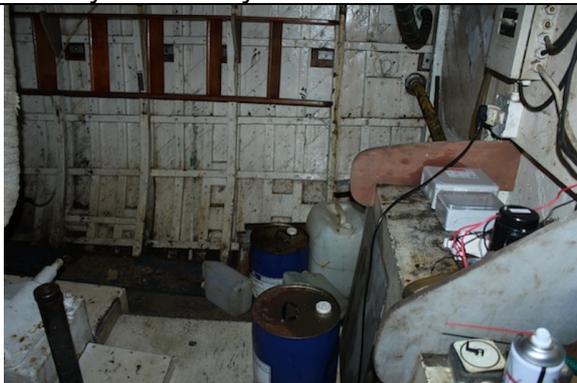
Engine room starboard side

The engine room was a bit of a mess. Extra batteries and a charger had to be added and the day tanks fully refurbished.
